COUNCIL REPORT

M&C No.	2019 - 24
Report Date	February 06, 2019
Meeting Date	February 11, 2019
Service Area	Saint John Water

SUBJECT: West Saint John – Corrosion Control Investigation

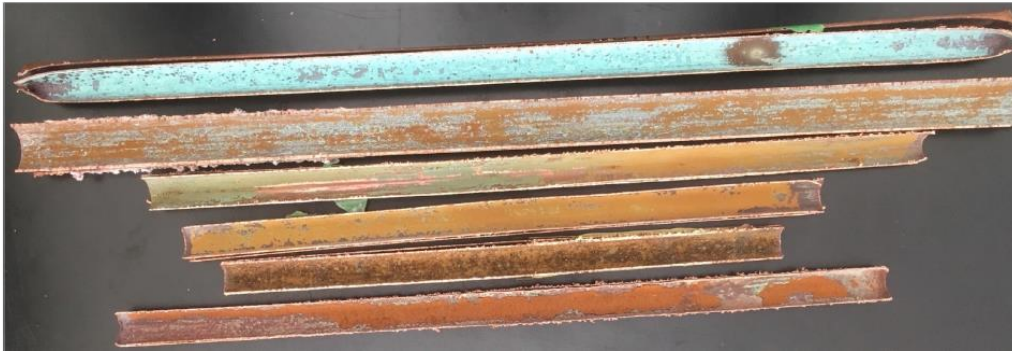
As stated in the CBCL report *"The initial analysis found that the scaling present was largely amorphous (does not have a distinct, identifiable crystalline structure) with some cuprite and malachite present (common copper scale materials), but not well defined. As such, the analyzed scale did not match copper scaling composition that is typically cited in literature. Amorphous corrosion scales commonly occur on copper piping; however as the composition of the scaling can vary greatly between systems, there is little research completed on amorphous scaling and copper solubility."* Figure 1 below shows examples of copper plumbing corrosion.

Figure 1. Sections of Copper Pipe cut longitudinally for scale analyses

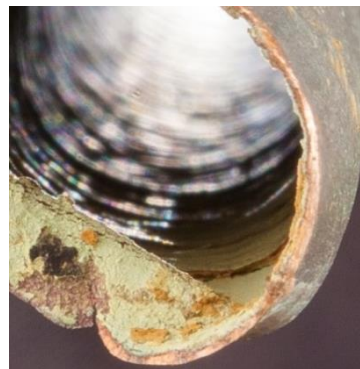
Figure 3. West Saint John Copper Pipe Close-up

This result aligns with the theoretical understanding communicated in January and February 2018 when some customers were reporting leaking copper pipes. See Figures 2 and 3 for a visual example of the scale existing on a copper pipe that came out of a West Saint John home.

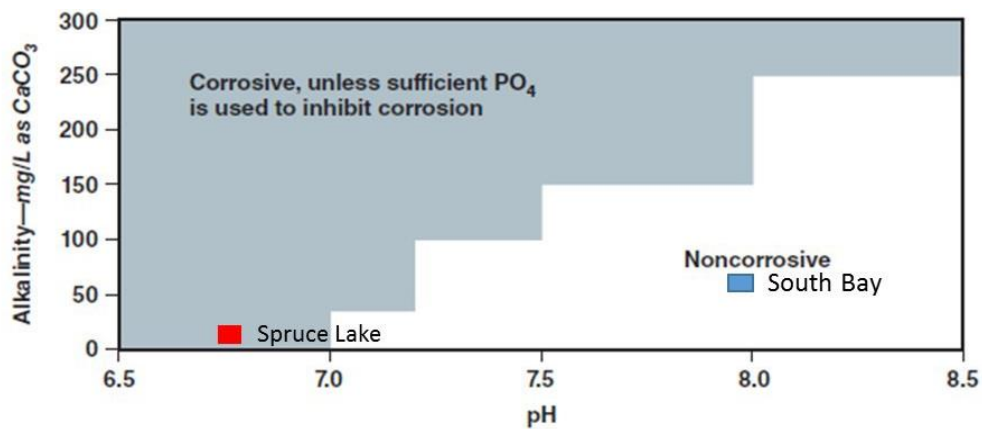
CBCL reported that “From a water quality standpoint, the source water switch from Spruce Lake to the South Bay Wellfield is considered low risk as the water quality was changing from a corrosive water to one that was less corrosive. Significant sampling was completed both at the wells and in the distribution system prior to the switch, however with regards to corrosion within the distribution system, the study was not as intensive as that for a system deemed a higher risk. See Figure 4 below (Figure 3-1 in the CBCL report) as the figure provides guidance as to when orthophosphate addition is required. As shown in the points plotted within the figure, South Bay is deemed to be noncorrosive and Spruce Lake is deemed to be corrosive.

Figure 4. (Figure 3-1 from CBCL report) Conditions that are Corrosive to Copper as Defined by the Lead and Copper Rule Working Group of the National Drinking Water Advisory Committee

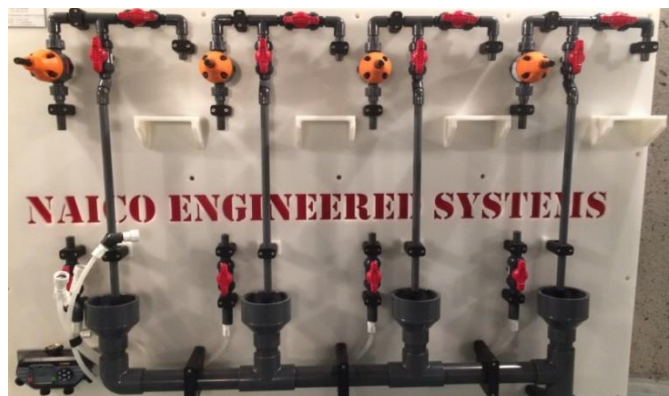
As a result of the reported leaks that occurred, the City developed a monitoring program for the distribution system and it will continue to evolve as more information is collected. The City is incorporating pipe racks as shown in Figure 4 below in several locations within the water distribution system, which contain sections of copper pipe. These sections of copper pipe can be representative of copper premise plumbing within the system. The pipe racks will allow the city to collect information relating to the ongoing monitoring of the effects of orthophosphate addition on premise plumbing.

Figure 5. One of the new pipe racks being incorporated into the Saint John water systems
