APPLICATION FOR A
HERITAGE PERMIT
21-0184

LORETTA MATTHEWS
51 ORANGE STREET
PID 00007815

Date	2021-04-01
To:	Heritage Development Board
From:	Growth and Community Services
Prepared by:	Benjamin Peterson
Approved by:	Jennifer Kirchner

Application for a Heritage Permit to demolish and reconstruct a non-character-defining front entry stairs and landings and to replace three wooden exterior doors with insert steel doors.

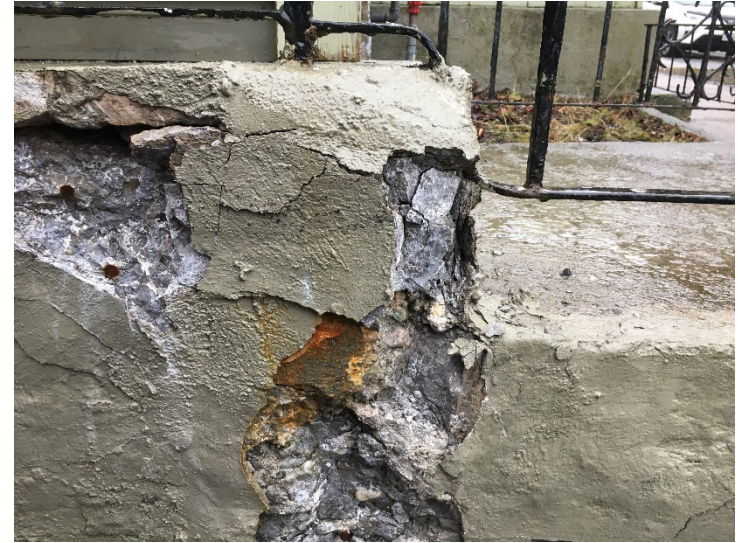
The proponent and their contractor have identified damage to many of the wooden and concrete elements that can not be easily repaired and would be best suited for replacement. Particularly, years of wear and weathering on the concrete pads and steps have resulted in chips and breaks that cannot be repaired in-situ and wood rot has begun to affect the steps.

View of water-infiltrated spalling concrete. West landing.

Approve the application for a Heritage Permit and permit the reconstruction of the front entry system and the replacement of three exterior doors and transoms with the proposed steel doors as presented.

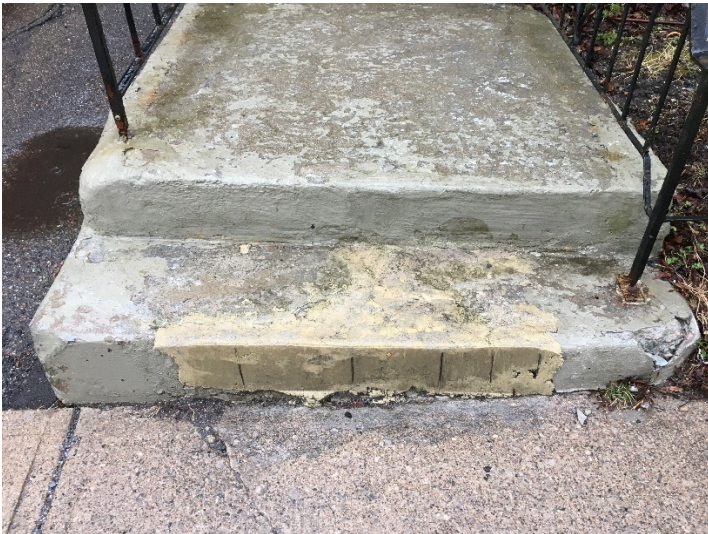
View of prior repair work. West landing.

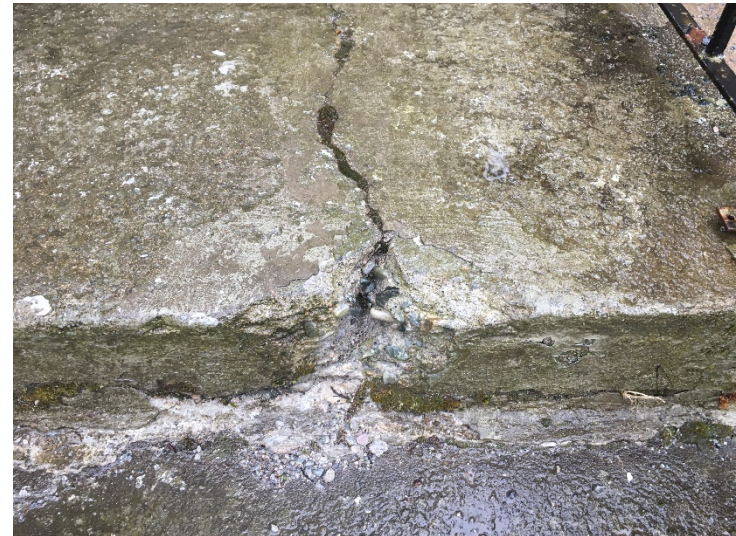
View of deteriorated concrete pad. East landing.

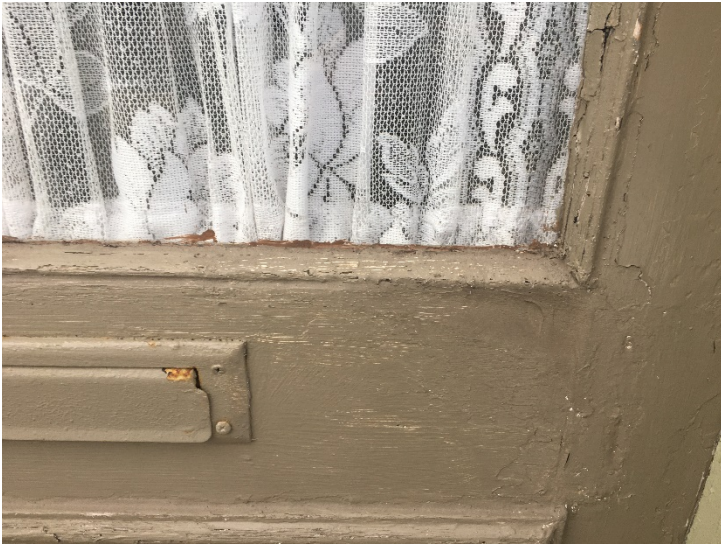
View of deteriorated filler around glazed panel on South-facing door.

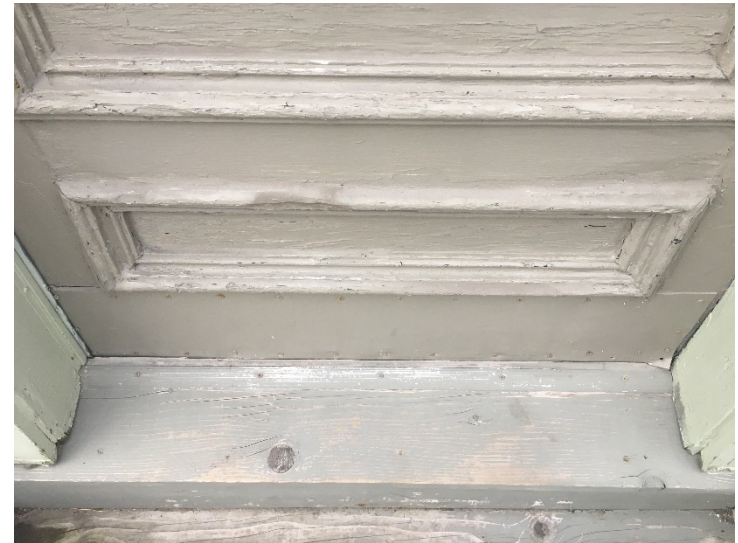
View of previous reinforcement on South-facing door.

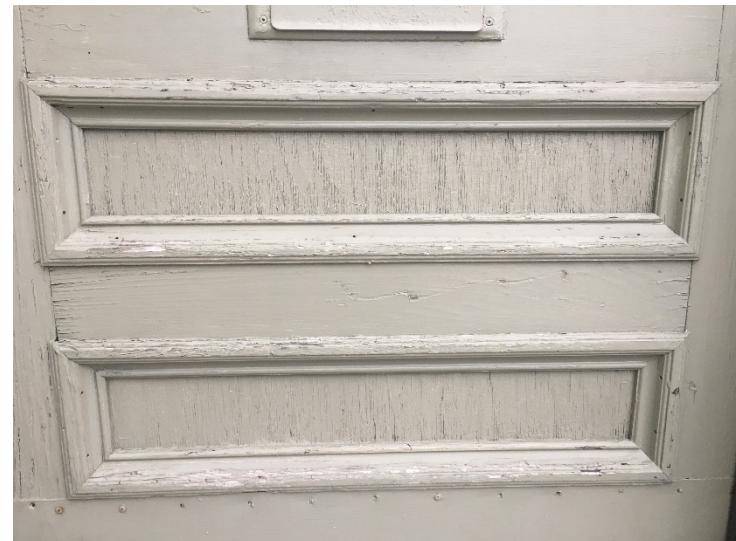
View of deteriorated plywood panels on West-facing door.
